Manhole Inspection Summary

Manhole # S21AA_070MH

Insp Date: **10/26/07 11:19 AM**

Location Address: **900 APPLETON-MONROE**

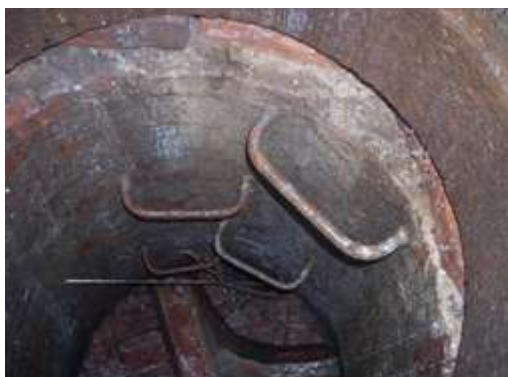
Defect 1

Count: **5** Missing: **0** ☒ **Corroded**

CORRODED STEPS

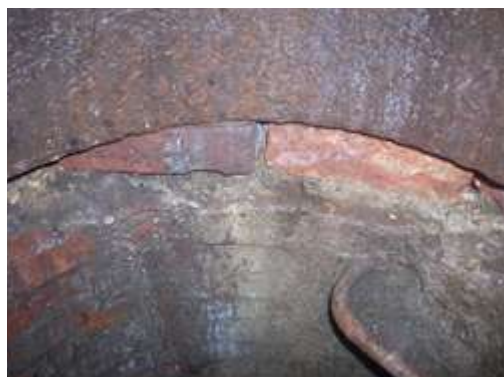
Defect 2

Condition: ☐ Sound ☐ Cracked ☐ Root Intrusion ☒ **Loose Brick** ☐ Deteriorated

LOOSE CHIMNEY BRICKS

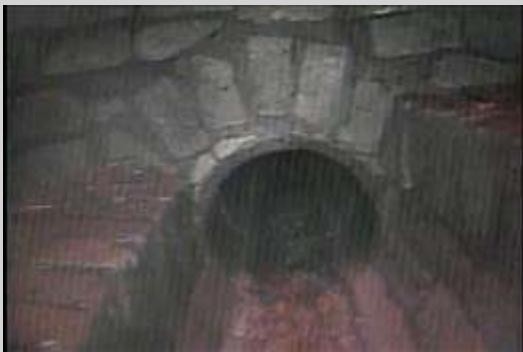
12 O'Clock Outflow

8 in. Circular Gravity Sewer
Pipe Out @ 12 O'Clock

Pipe Height: **7.2** (in.) Rod and Bar (Angled)
Pipe Material: **Clay** ☐ Pipe Lined
Invert Depth: **8.55** (ft.) Flow Characteristics: **Slow**
Deposits: ☒ None ☐ Mud ☐ Sludge ☐ Debris ☐ Grease
Silt Depth: (in.) Deposits Extent:
Infiltration: **None** Pipe Seal Cond: **Sound**

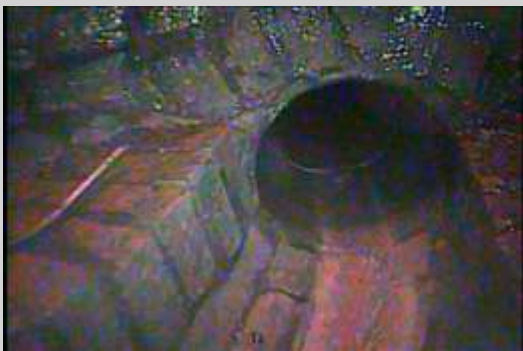
3 O'Clock Inflow

8 in. Circular Gravity Sewer
Pipe In @ 3 O'Clock

Pipe Height: **8.4** (in.) Rod and Bar (Angled)
Pipe Material: **Clay** ☐ Pipe Lined
Invert Depth: **8.03** (ft.) Flow Characteristics: **Slow**
Deposits: ☒ None ☐ Mud ☐ Sludge ☐ Debris ☐ Grease
Silt Depth: (in.) Deposits Extent:
Infiltration: **None** Pipe Seal Cond: **Sound**

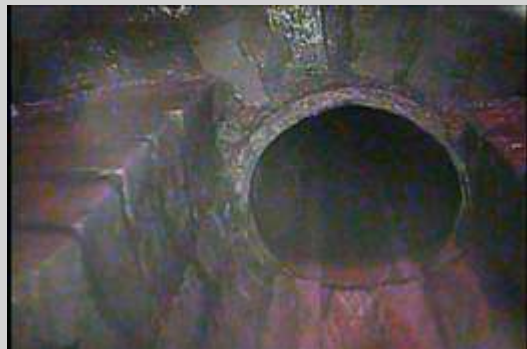
6 O'Clock Inflow

Pipe In @ 6 O'Clock

Infiltration: **None** Pipe Seal Cond: **Sound**
